Manhole Inspection Summary

Manhole # S17AA1020MH

Insp Date: **2/28/07 10:07 AM**

Location Address: **2284 PARK HILL AVE**

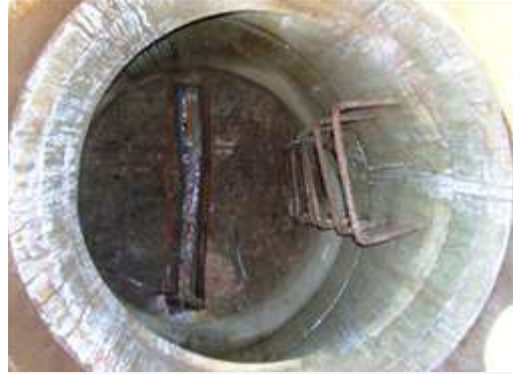
Top View

Corroded steps. Evidence of surcharge - Bench debris.

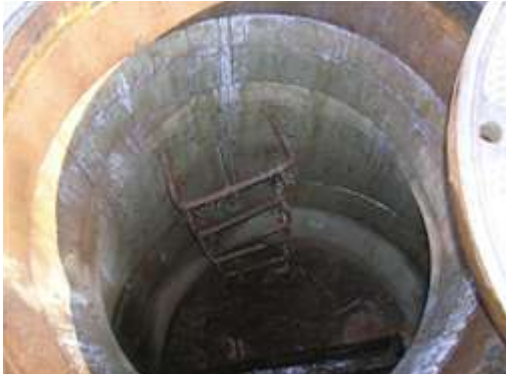
Defect

Frame leaks. Adjustment infiltration.

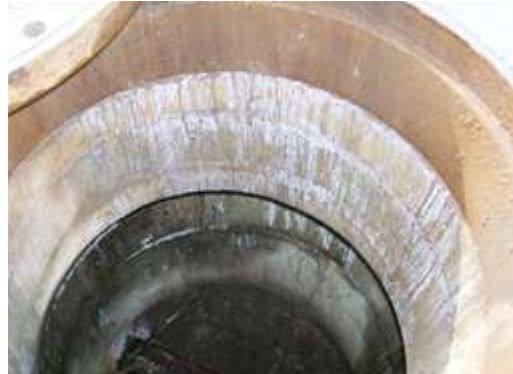
Defect

Frame leaks. Adjustment and Barrel infiltration.

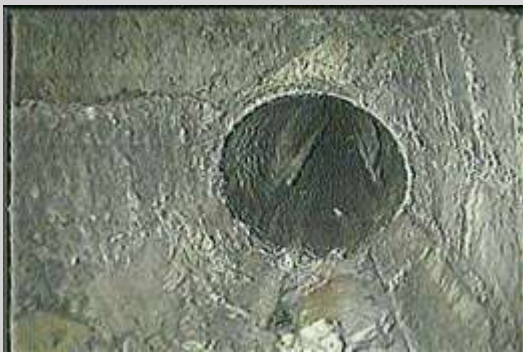
8 in. Circular Gravity Sewer Pipe Out @ 12 O'Clock

Deposits: ☐ None ☐ Mud ☐ Sludge ☒ **Debris** ☒ **Grease**

Infiltration: **Evidence** Pipe Seal Cond: **Unknown**

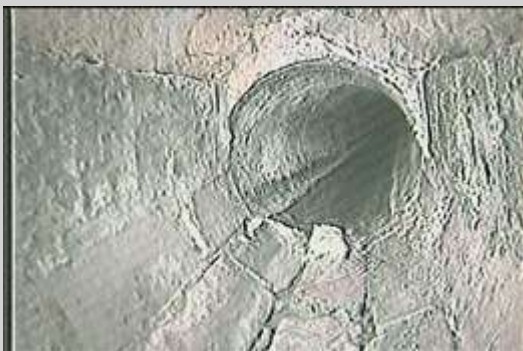
8 in. Circular Gravity Sewer Pipe In @ 6 O'Clock

Comments **The I6 pipe picture shows Channel deterioration.**

Deposits: ☐ None ☐ Mud ☐ Sludge ☒ **Debris** ☒ **Grease**

Infiltration: **Evidence** Pipe Seal Cond: **Unknown**
